## *Home Inspection Report*

**123 Spring St. Owasso, OK 74055**

**Inspection Date: 04/13/2017**

**Report Number: 04132017-01**

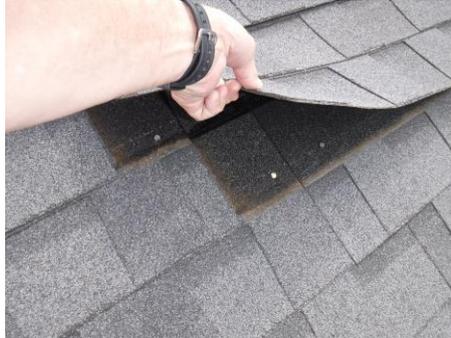
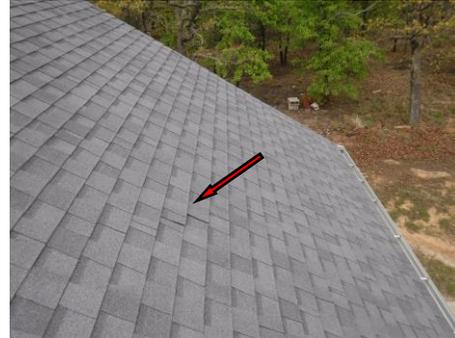
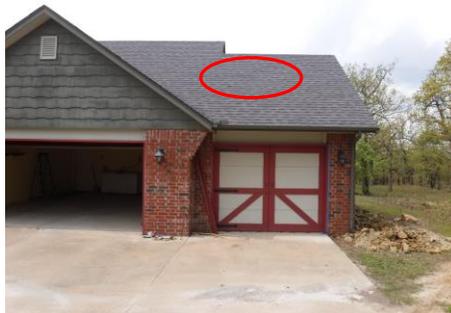
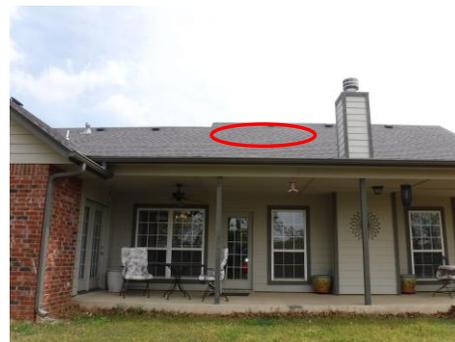
- **Monitor, Repair:** Loose tabs were observed. Repairs are recommended. *Front and Back Sides of Roof.*

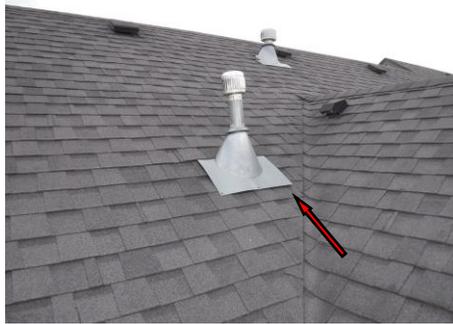
- **Repair:** The flashing is loose and should be re-secured to avoid leaks. *Water Heater Chimney.*

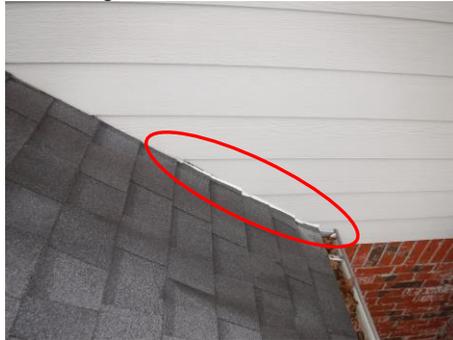
- **Monitor:** The flashing is vulnerable, has leaked in the past, and should be watched carefully for leaks.

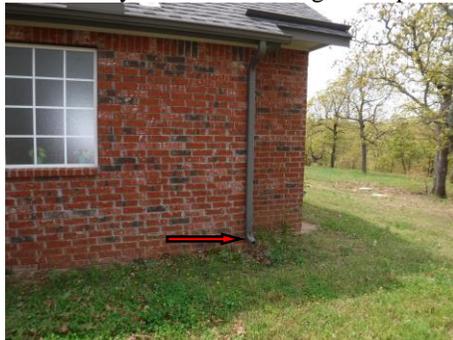
- **Recommend:** The downspout(s) should discharge water at least five (5) feet from the house. Storm water should be encouraged to flow away from the building at the point of discharge.

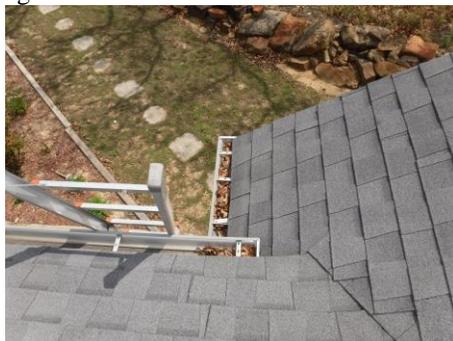
- **Repair:** The gutters require cleaning to avoid spilling roof runoff around the building – a potential source of water entry or water damage.

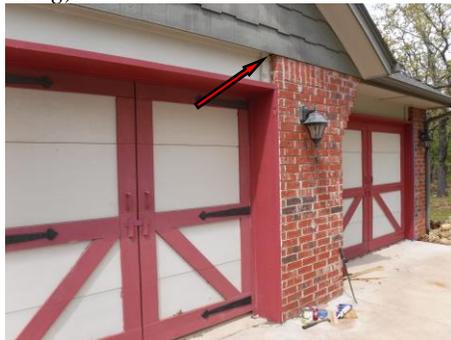
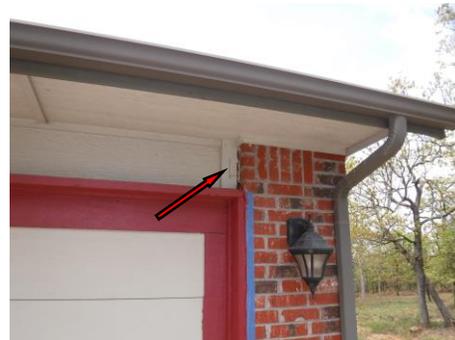
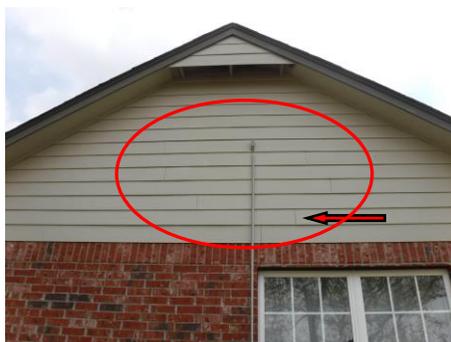
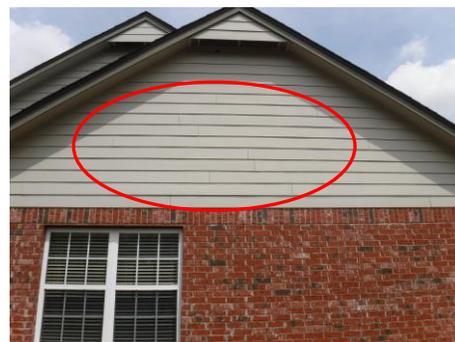
- **Repair:** Any openings in the exterior siding should be sealed. *Front of House (see pictures) and Siding (openings between lap siding).*

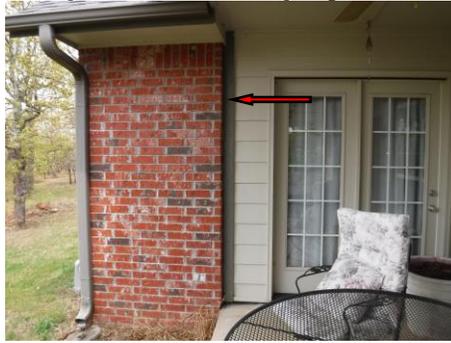
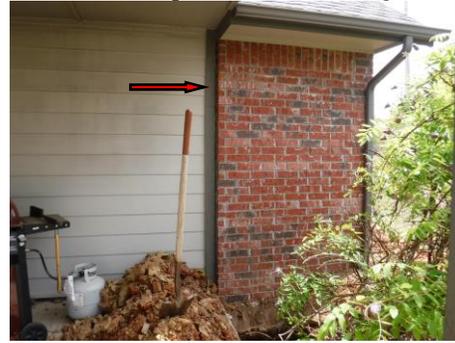
- **Repair:** The siding trim needs caulking improvements in localized areas to prevent water damage and rot. *See Pictures.*

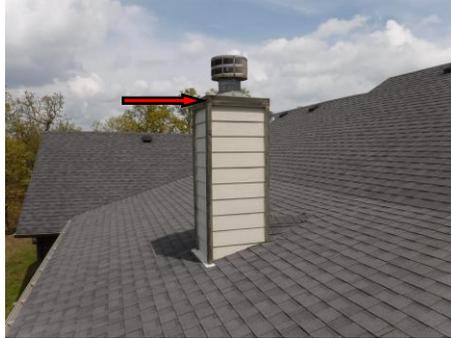
- **Repair:** Localized rot was observed in the trim around the siding. *Fireplace Chimney Chase.*

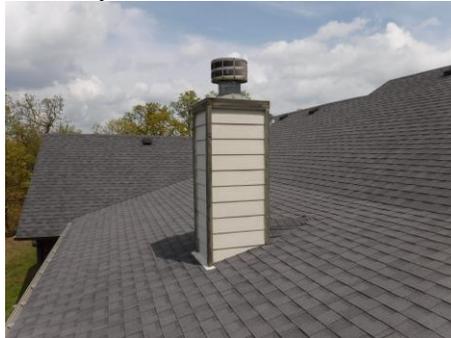
- **Repair:** The paint on the trim around the siding is peeling. These areas should be painted to prevent water damage and rot. *Fireplace Chimney Chase.*

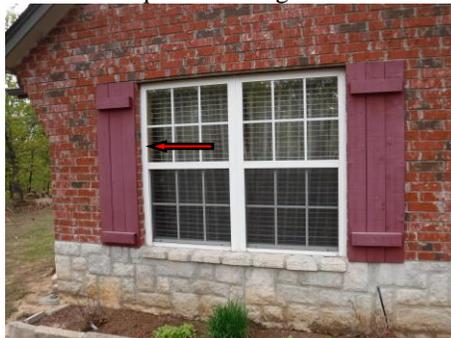
- **Repair:** The windows require caulking.

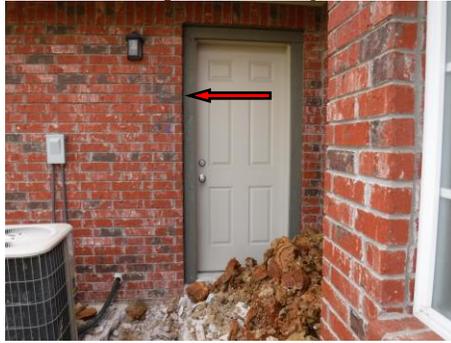
- **Repair:** The door frame requires caulking. *Exterior Garage Access Door.*

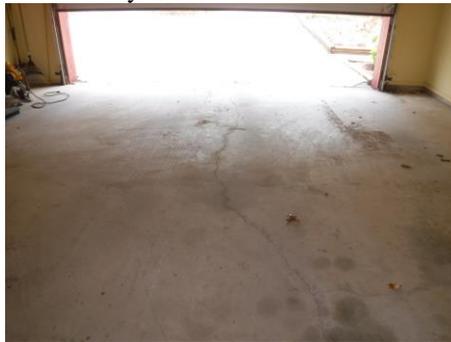
- **Monitor:** The garage floor slab has typical cracks usually the result of shrinkage and/or settling of the slab as it cures. Shrinkage cracks are very common and are not normally a concern.

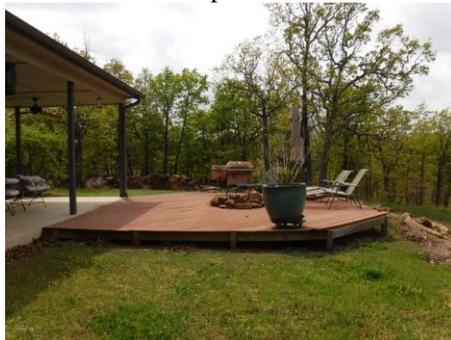
- **Monitor, Repair:** The support posts for the deck are below the soil. This configuration is prone to rot. Rising above soil level is recommended. The potential of rot could already be present.

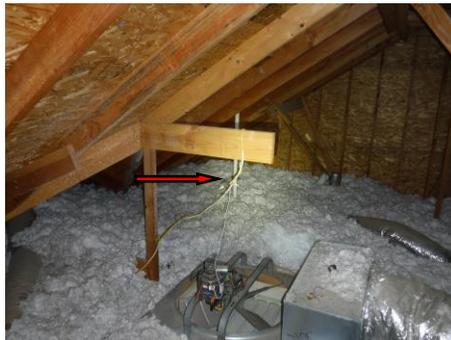
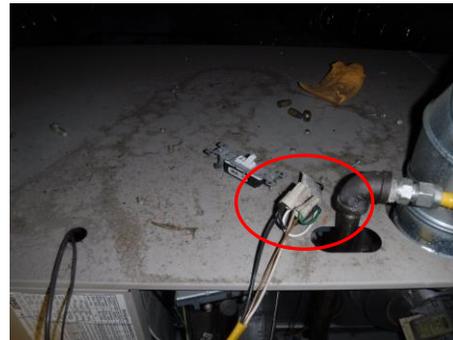
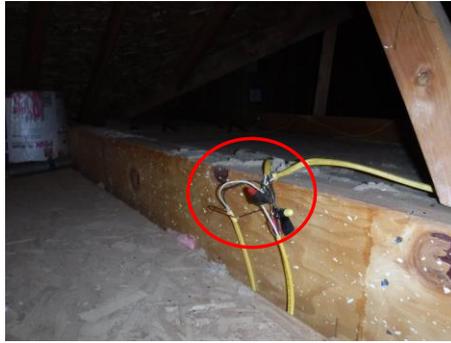
- **Repair:** All spliced wiring should be placed in junction boxes and junction boxes should be fitted with cover plates, in order to protect the wire connections. *Attic.*

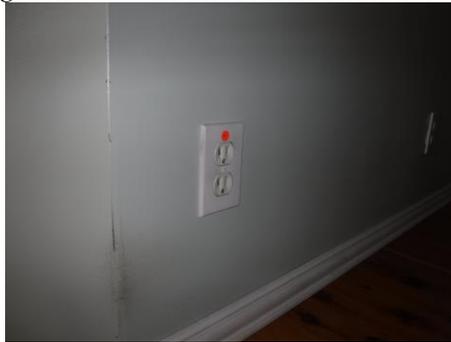
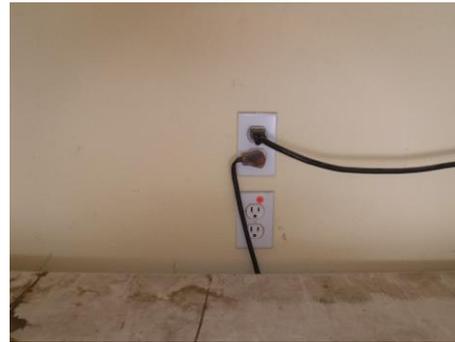
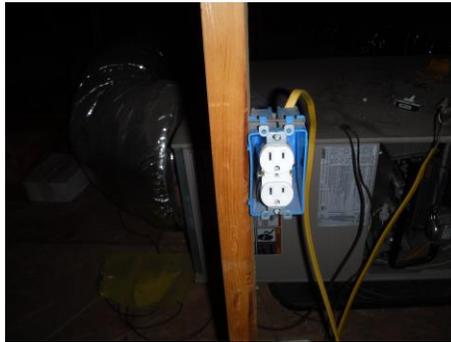
- **Repair:** An outlet is inoperative. This outlet and circuit should be investigated. *Livingroom, Garage and Attic. Marked with an orange sticker with an "X".*

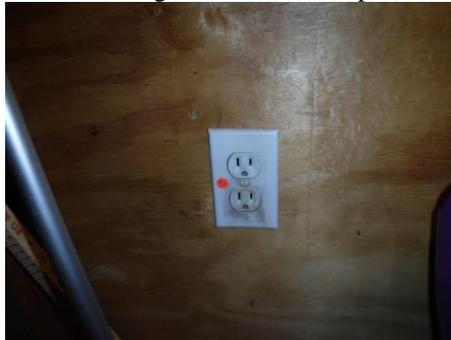
- **Repair:** An outlet is damaged. It should be replaced. *Pantry. Marked with an orange sticker with a "D".*

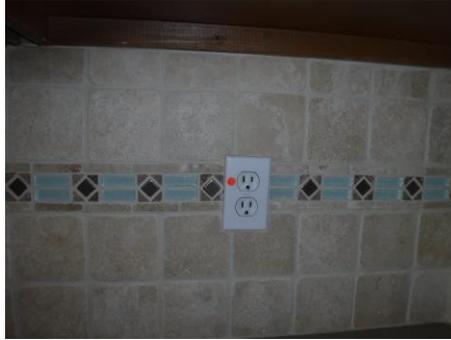
- **Repair:** An outlet is loose. It should be repaired. *Kitchen. Marked with an orange sticker with an "L".*

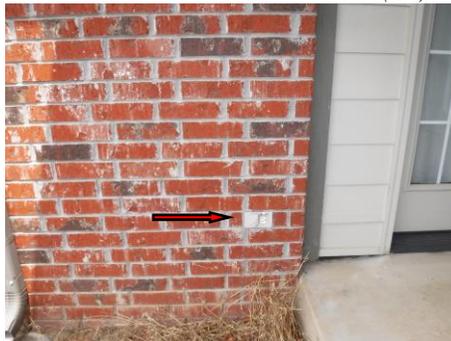
- **Repair:** The installation of a ground fault circuit interrupter (GFCI) is recommended. A GFCI offers increased protection from shock or electrocution. *Exterior (all).*

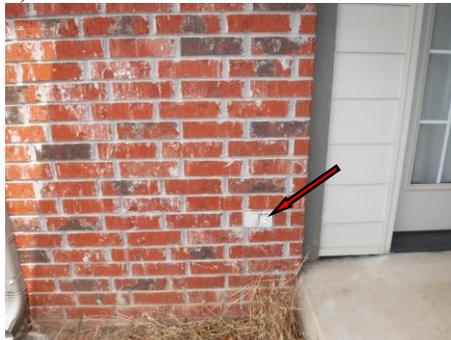
- **Repair:** Damaged outlet cover should be replaced to avoid a shock hazard and water damage to the outlet. *Exterior (back of house).*

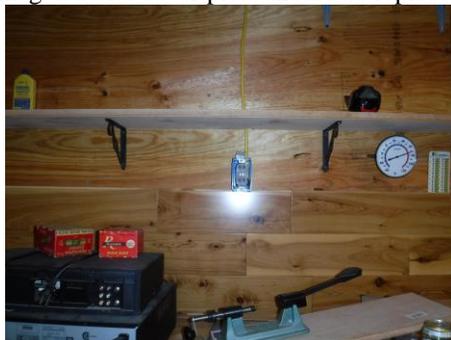
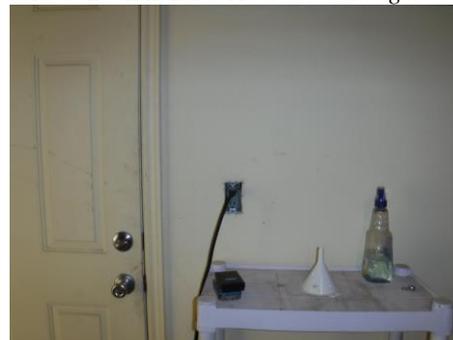
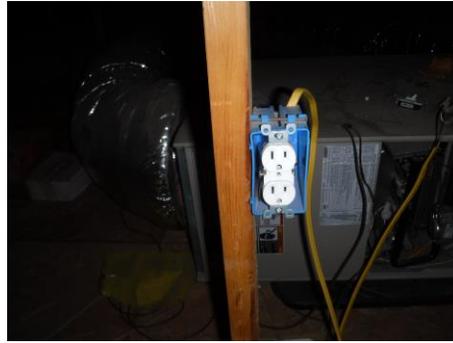
- **Repair:** Damaged outlet cover plate should be replaced to avoid a shock hazard. *Attic and Garage.*

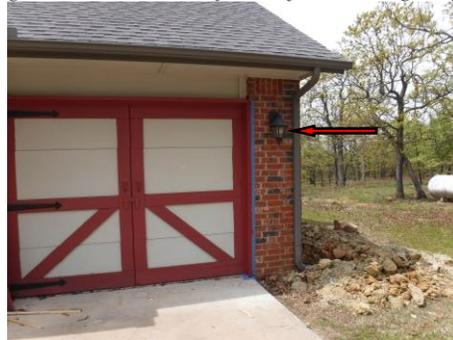
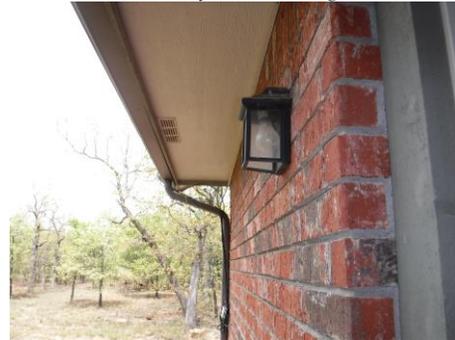
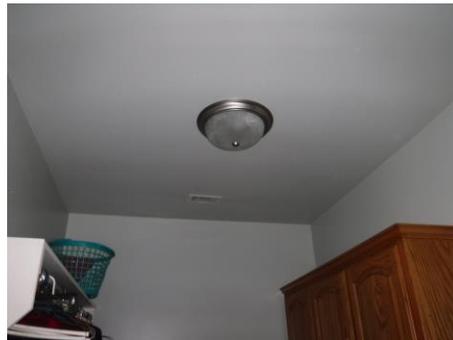
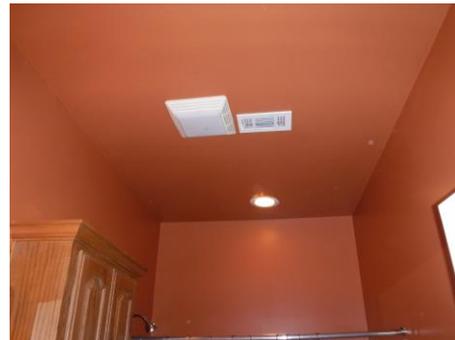
- **Repair:** The light is inoperative. If the bulbs are not blown, the circuit should be repaired. *Exterior (back of house at exterior garage access door and front of house at garage) and Interior (laundry room and guest bathroom; exhaust fan).*

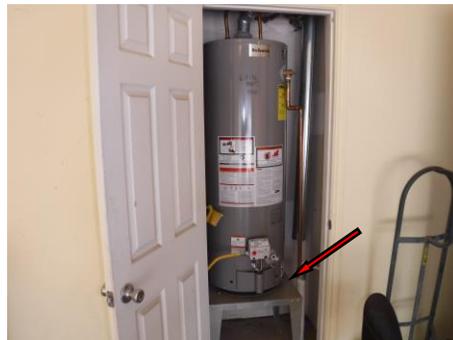
- **Repair:** In order to reduce the potential for water damage, it is recommended that an auxiliary drain pan be installed below the water heater.

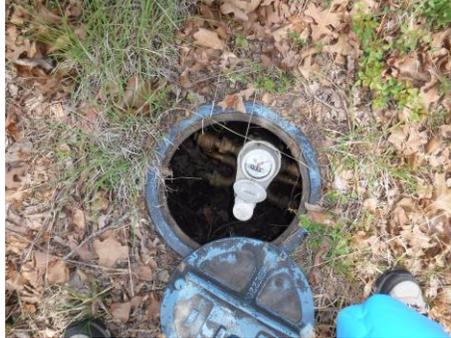
- **Possible Concern, Monitor, Repair:** The main water supply piping to the house from the water meter appears to be leaking. *The meter was running. The toilet in the guest bathroom is running slightly. After repairs to the toilet are complete, if the meter is still running, further investigation should be done by a licensed plumber to find the leak.*

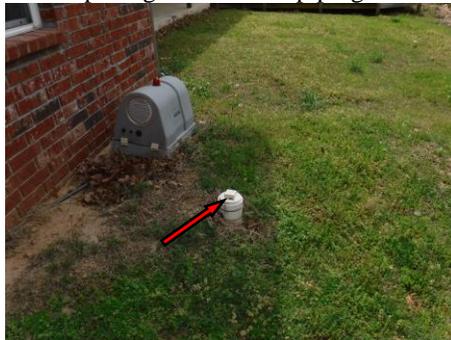
- **Repair:** Unsealed opening in the waste piping should be corrected. *Back Yard (waste clean out; damaged cap).*

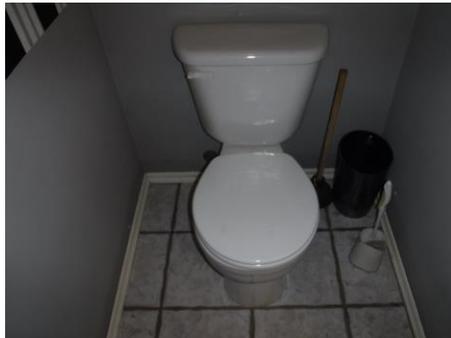
- **Repair:** The toilet is loose. *Master Bathroom.*

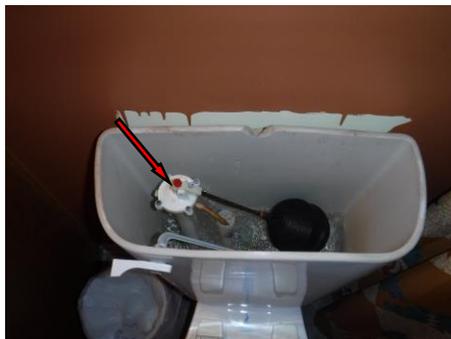
- **Repair:** The toilet tank fill valve is damaged. Replacement of the tank mechanism is needed. *Master Bathroom and Guest Bathroom.*

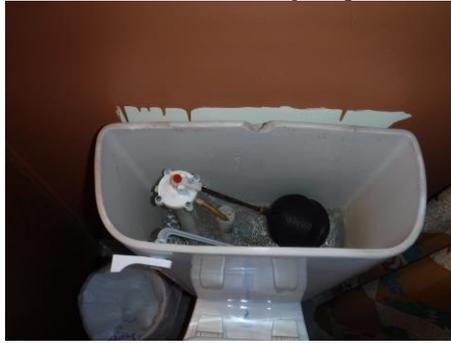
- **Repair:** The toilet runs on after flushing. Improvement to the tank mechanism is likely to be needed. *Guest Bathroom.*

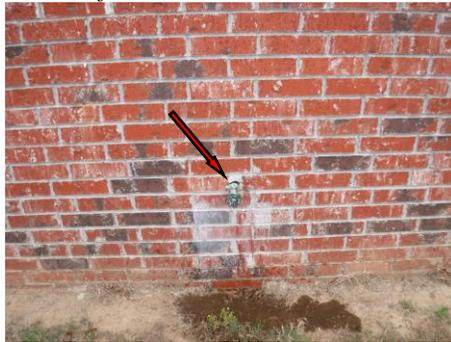
- **Repair:** The hose bib leaks from the anti-siphon cap when the water is running. The anti-siphon valve needs to be replaced. *South Side of House.*

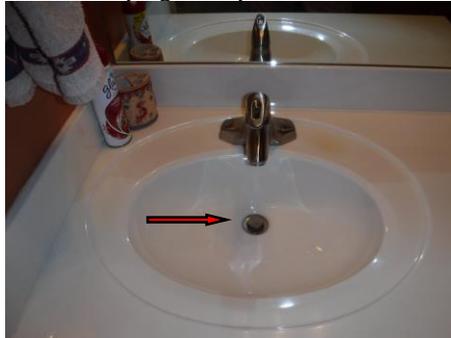
- **Repair:** The sink drain plug is inoperative and needs repair. *Guest Bathroom.*

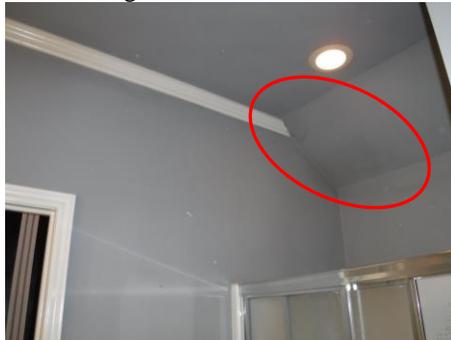
- **Monitor:** Water staining was noted. *Master Bathroom (ceiling and wall).*

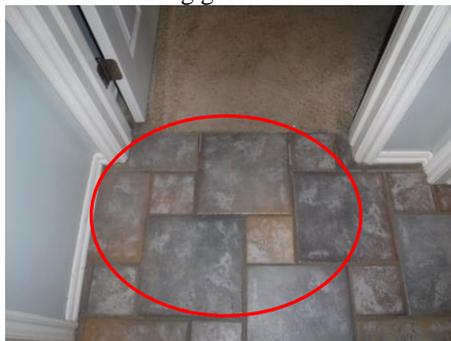
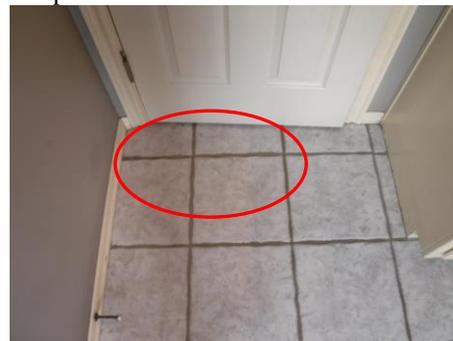
- **Repair:** Loose and/or missing grout in the tile floor should be repaired. *At Master Bedroom and Master Bathroom.*

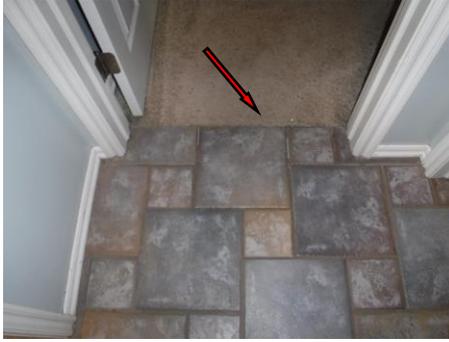
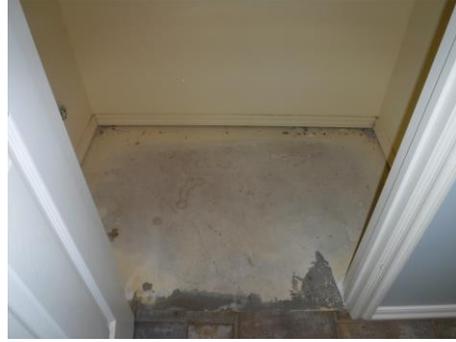
- **Monitor, Repair:** The carpet flooring is damaged. *Master Bedroom (at door) and Entryway Closet (missing flooring).*

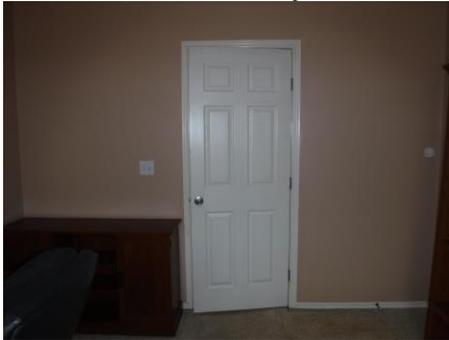
- **Repair:** Doors should be trimmed or adjusted as necessary to work properly. *Front Bedroom.*

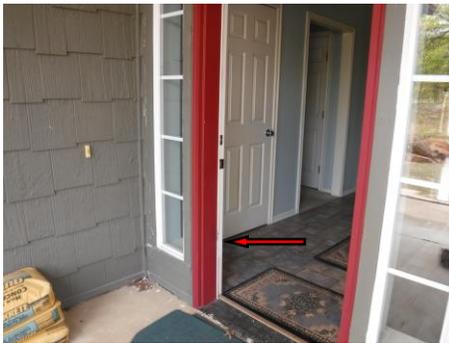
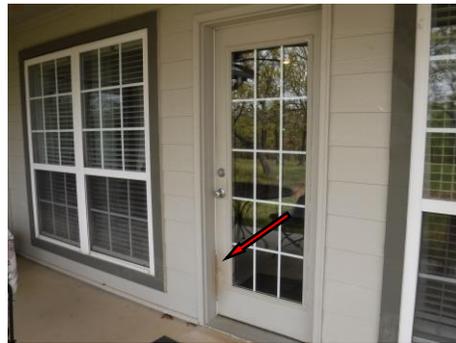
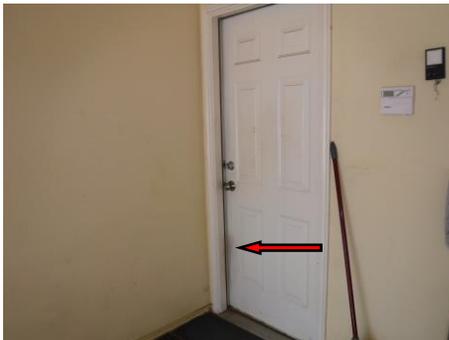
- **Repair:** The weather strip on the front door, interior garage access door and back door is damaged and/or missing. Repair is needed.

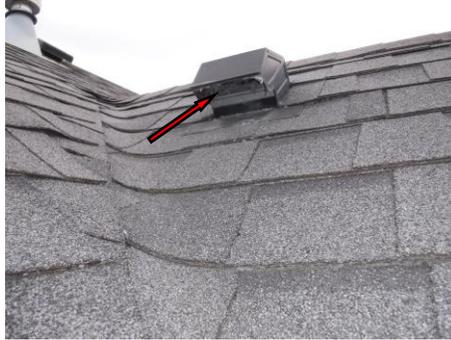
- **Monitor, Repair:** The clothes dryer vent should be cleaned.
